Notice of termination photo guidance- construction stormwater permits

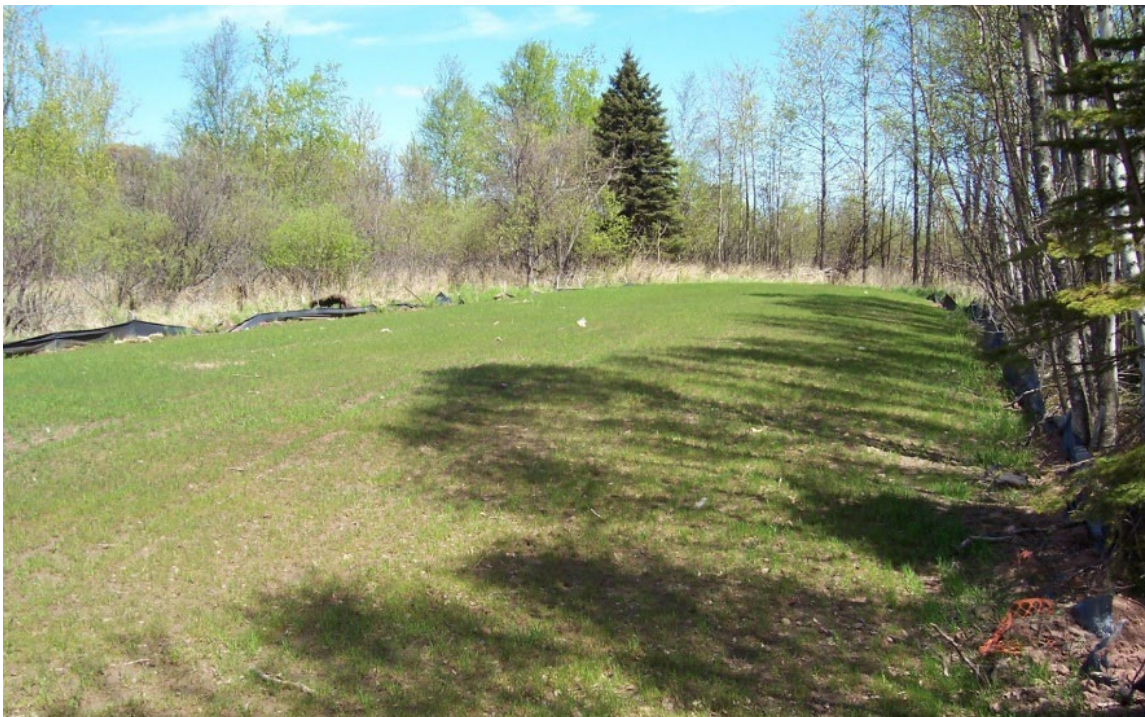
This image shows an acceptable vegetative cover, as it appears to be 70% or greater. However, the MPCA recommends removing silt fence when no longer needed, as it is in this case.

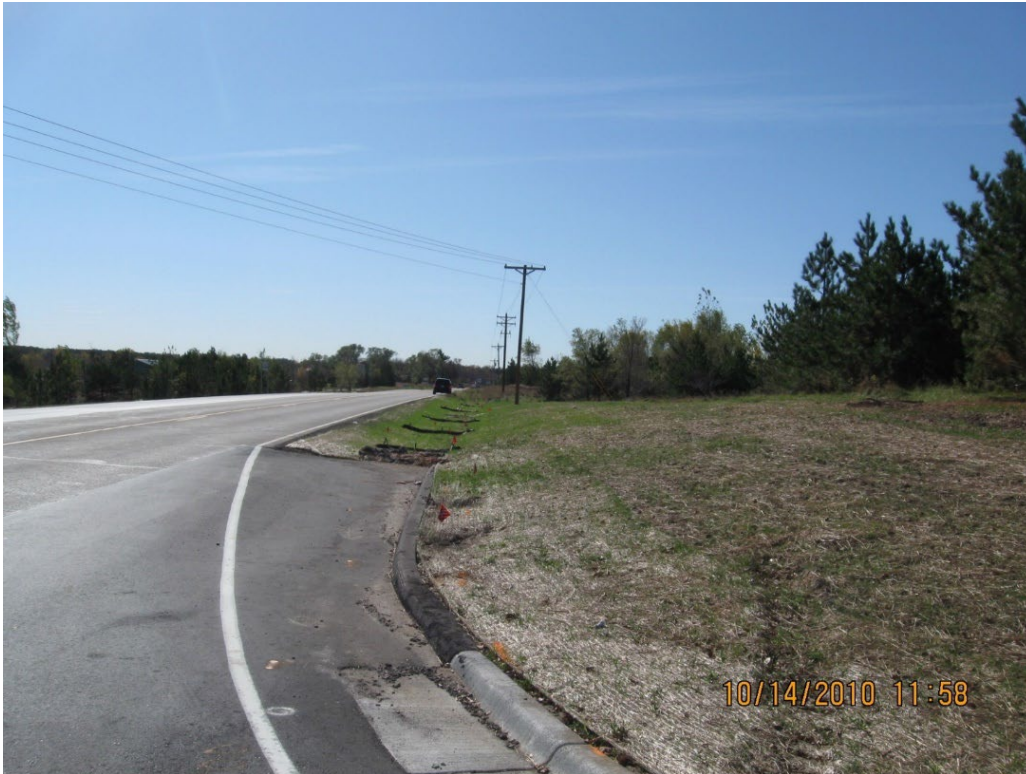
This image shows around 50% vegetative cover and would not be acceptable.

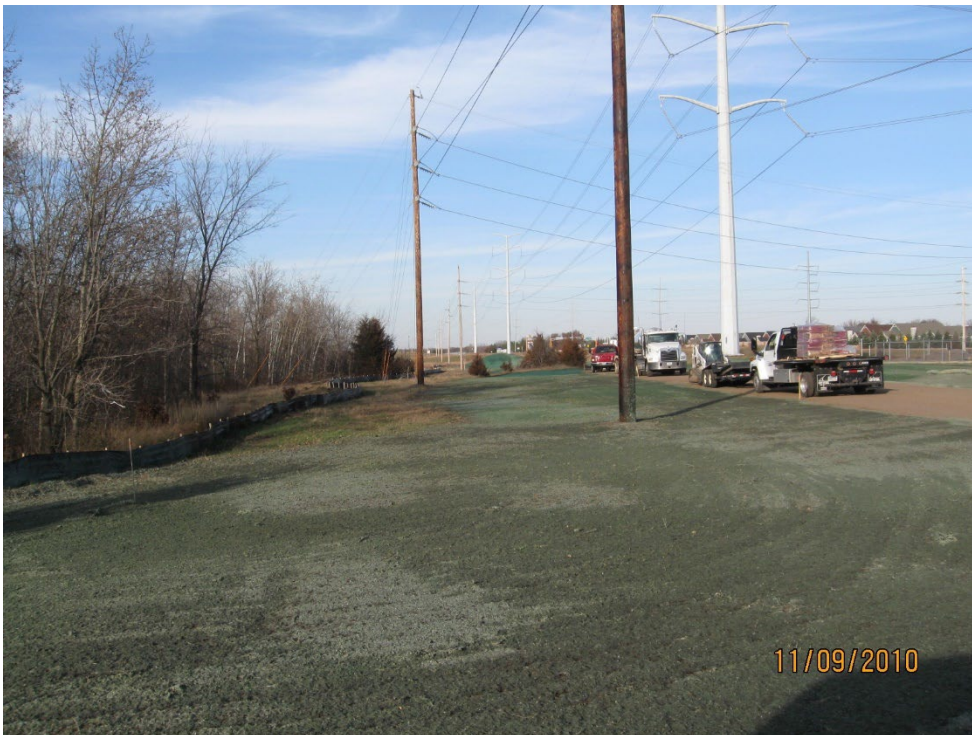
This image shows ground that has been disturbed and then stabilized with temporary hydraulically applied erosion control. This is not permanent vegetative cover and would not be acceptable.

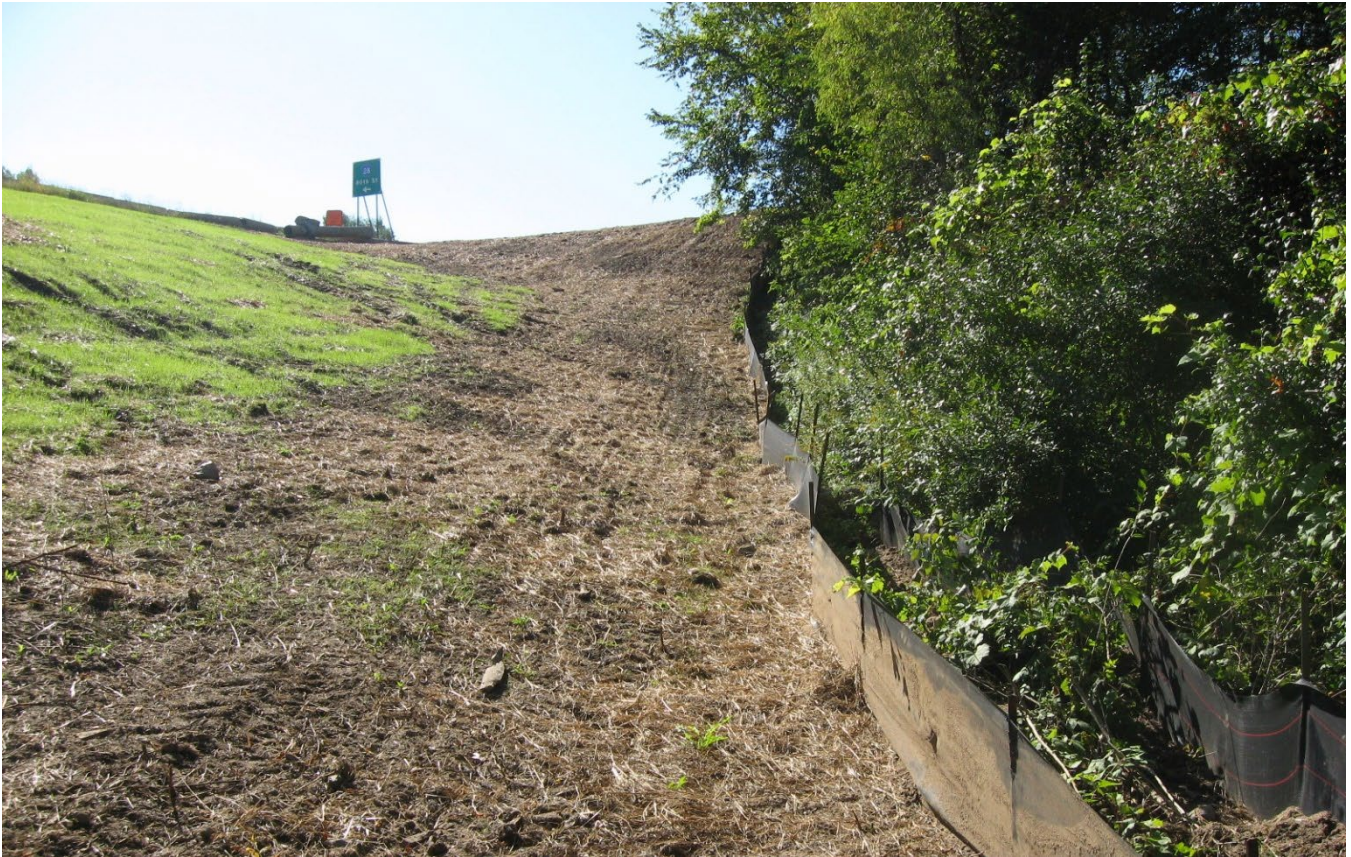
This image shows around 10% cover and would not be acceptable.

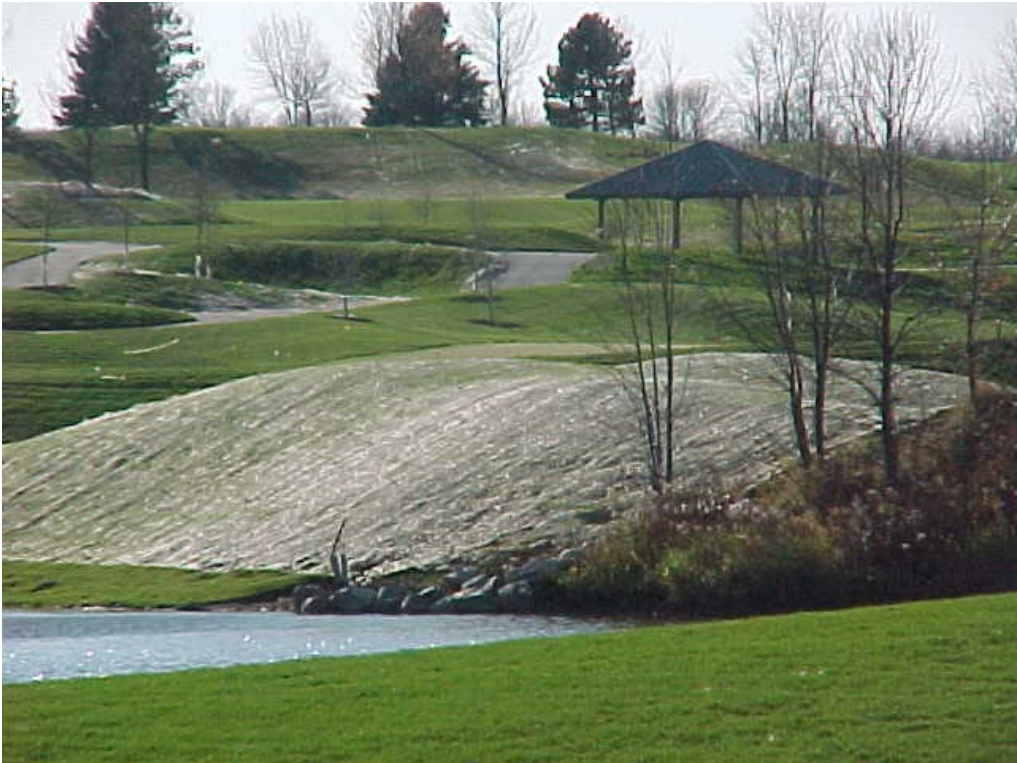
While the surrounding areas have plenty of vegetative cover, the area with erosion control blankets has around 10% vegetative cover and would not be acceptable.

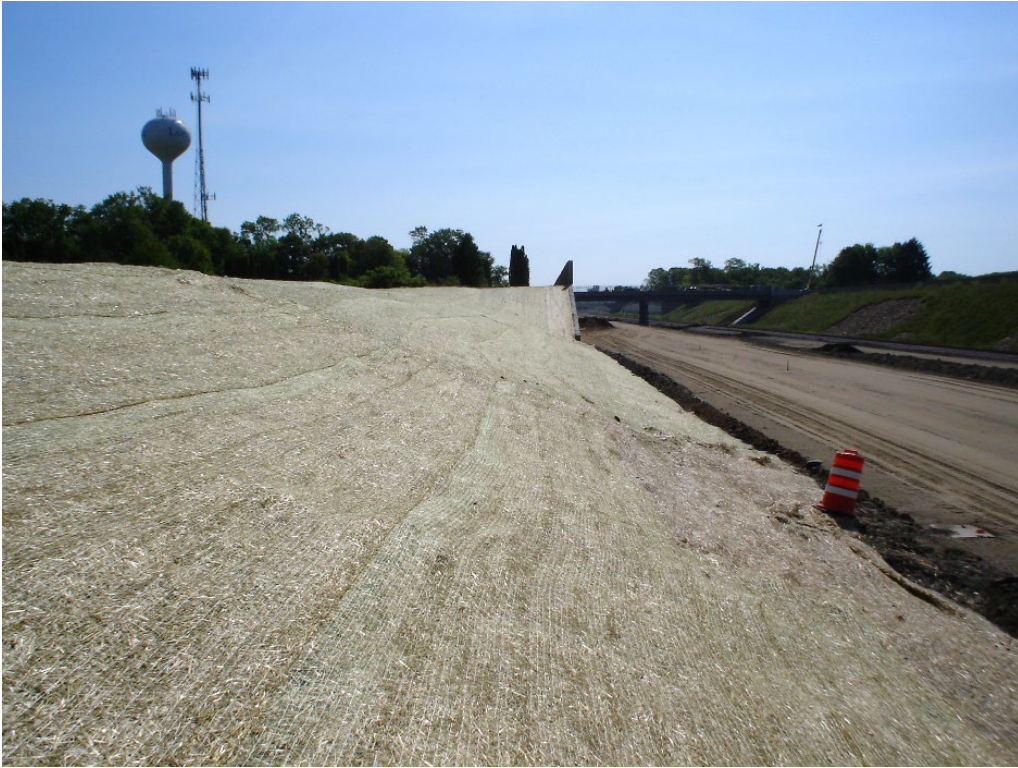
This slope appears to have no vegetative cover, as well as adjacent ongoing construction, and would not be acceptable.

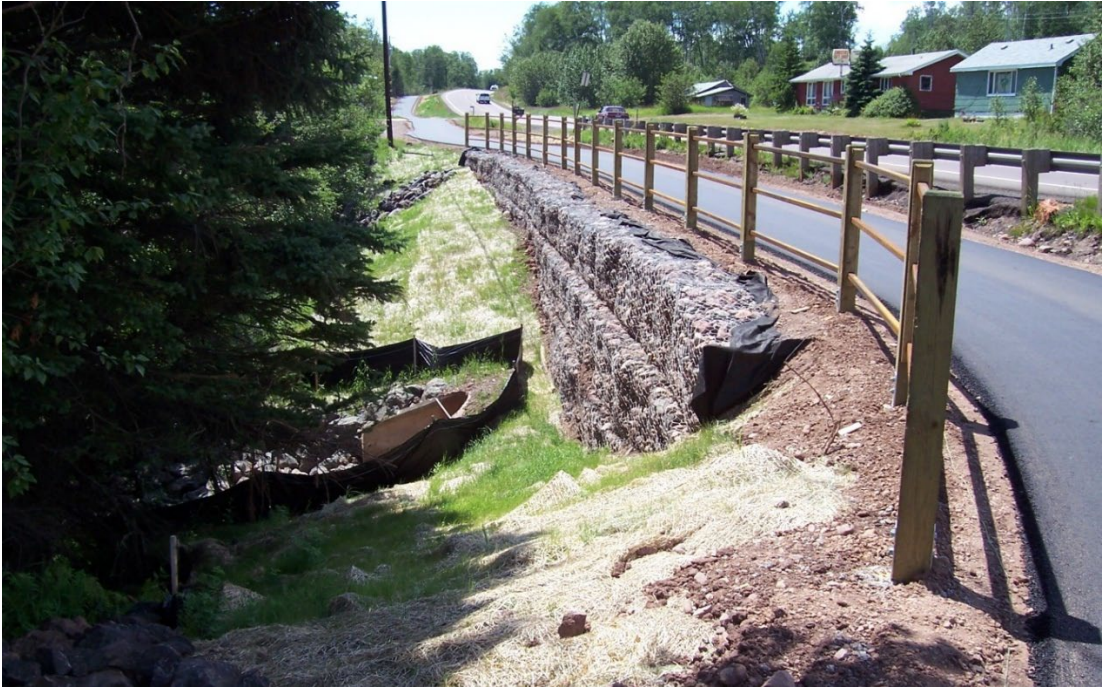
This image shows vegetative coverage of around 50%v and would not be acceptable.

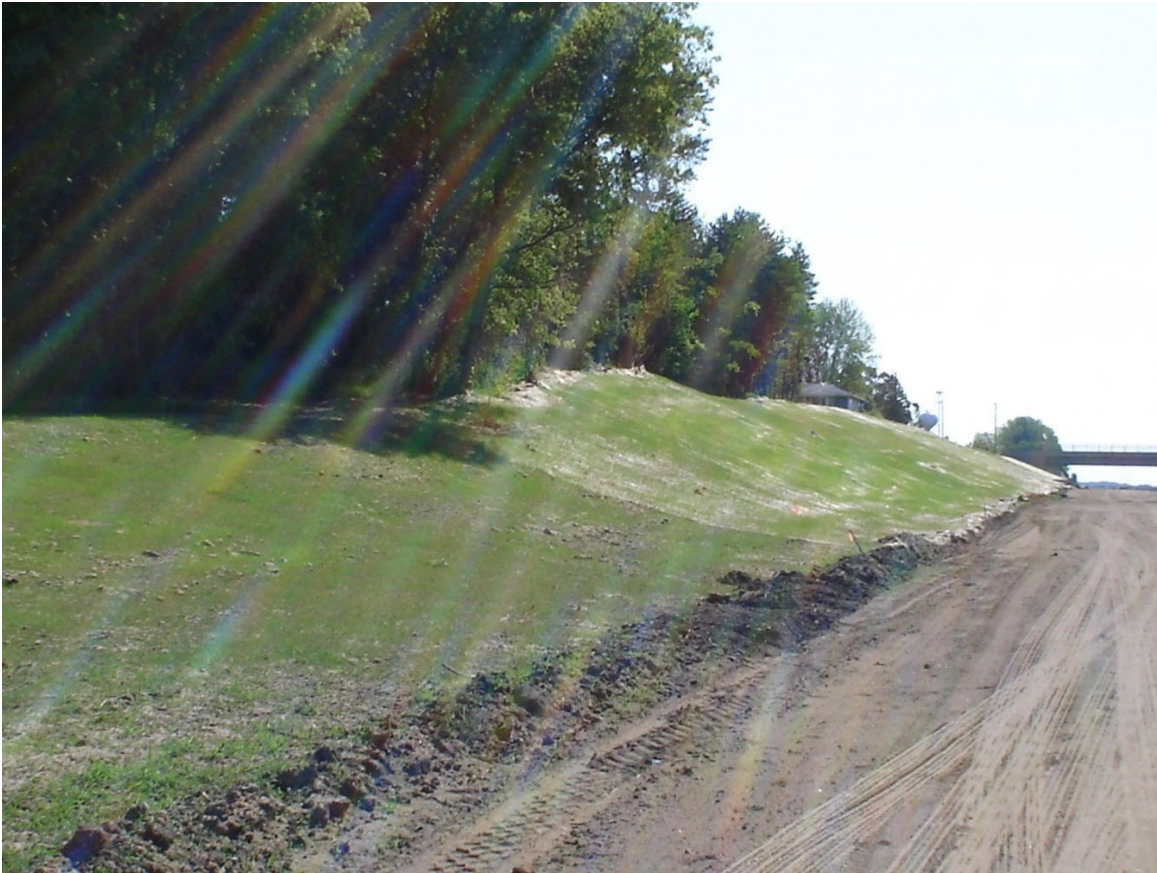
While the vegetative coverage in this image would be acceptable, as it appears to be 70% or above, there appears to be ongoing construction on the site and permit termination would not be allowed.

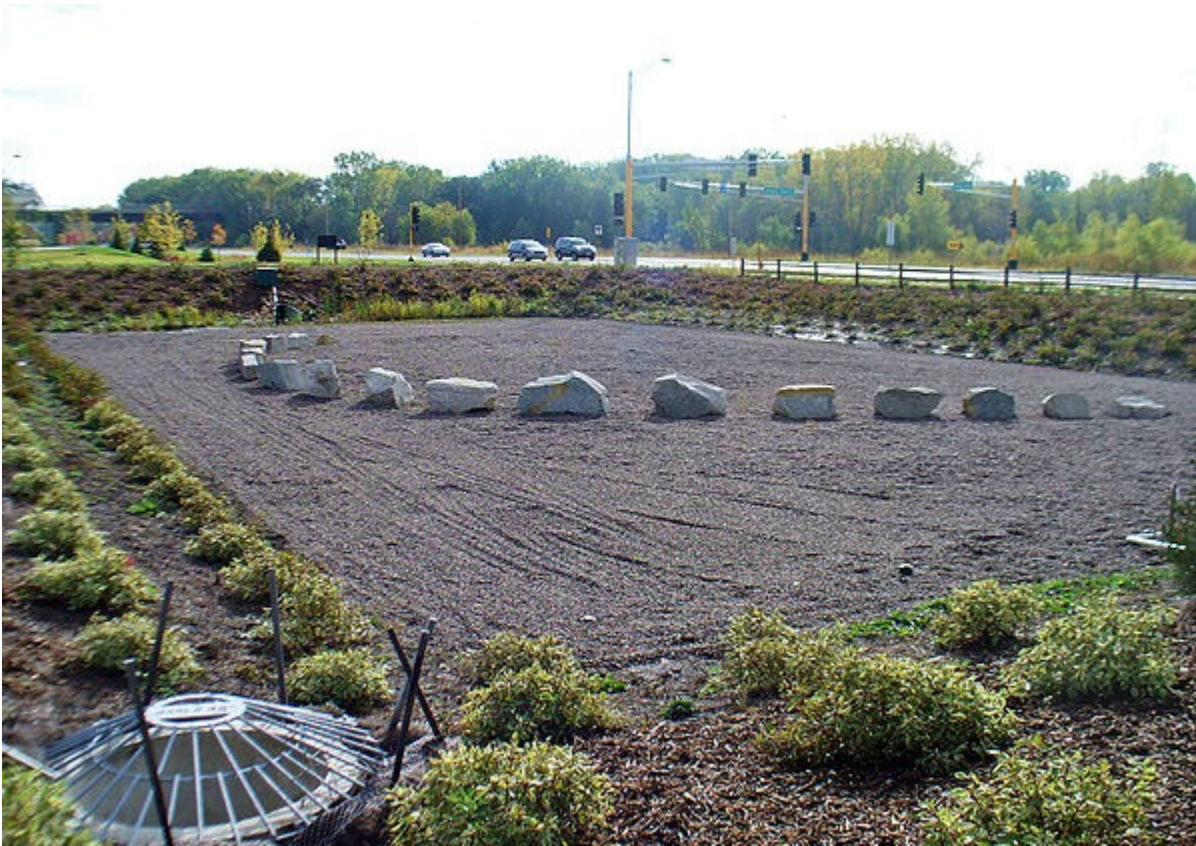
This sand filter system is intended to have a non-vegetated surface. Photo courtesy of [Ramsey-Washington Metro Watershed District](#).

Vegetation is not required where it would interfere with the function of a specific area, such as impervious surfaces or the base of a sand filter.
