Burnsville rain gardens - retrofitting for water quality

Information: This page was created for the original Stormwater Manual in 2005. Information may be outdated.

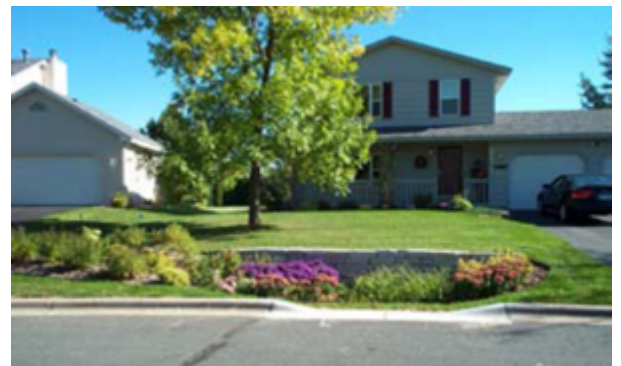
Photo showing one of the rain gardens installed as part of the Burnsville rain garden project.

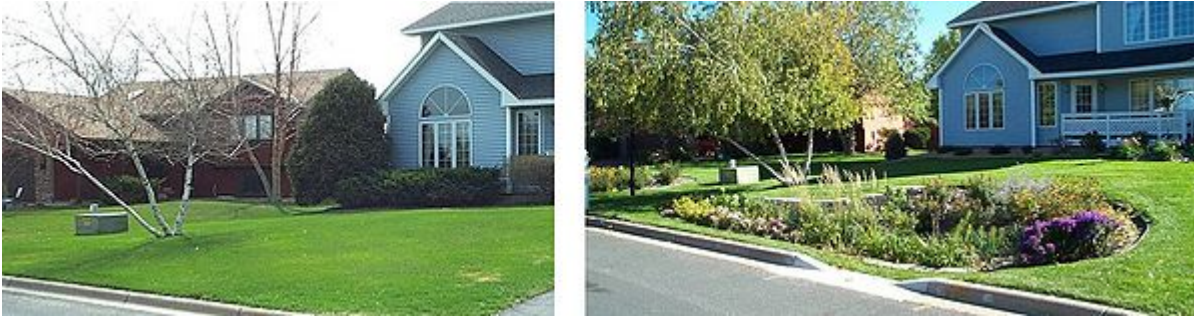
Photos illustrating a private residence before and after installation of a rain garden. Notice the curb cut from the street into the rain garden.

In order to let plants become established before being inundated, curb cuts were not made until spring 2004. It is important to design curb cuts sufficiently wide so stormwater actually reaches the gardens; a too-narrow cut can allow water to wash on by. At Burnsville, the typical curb opening was 6 feet, with 2 feet tapering sections on each side.

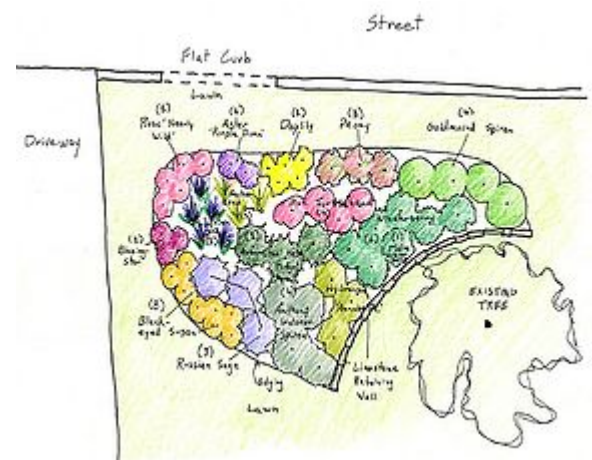
Schematic showing the design for a rain garden. Note the placement of plants within different locations in the rain garden.

Since the greatest concentration of pollutants is washed off impervious surfaces during the first inch of precipitation, rain gardens are designed to accommodate that “first flush” from a given watershed. The Burnsville gardens were designed to accommodate 0.9 inches and drain rapidly, within 24 to 48 hours. Rain gardens can be planted with many types of vegetation, including native perennials and shrubs or cultivated varieties. The Burnsville participants were given the choice of three basic garden styles: native wildflower, cultivated perennials and/or shrubs.

The landscape architect met with homeowners and drew up planting plans that considered individual resident preferences. Each garden is separated from the street and curb cut by a mow strip, which serves two purposes: to lend a neat, intentional edge to the garden and to trap sediment traveling with the rainwater. The planting designs emphasize showy groupings of tidy-looking plants, which enhance the appearance of the front yards. Construction began in fall 2003. In order to avoid hitting utilities and to ensure proper flow, precise grading of the gardens was critical, as was close adherence to soil specifications and avoiding compaction. Native sandy topsoil was stockpiled and mixed with compost, then installed at a depth of 12 inches following grading. To ensure quality, the city relied on the engineering consultant to do extensive construction observation, and Gopher One marked utilities two additional times—before sod stripping and soil removal and also prior to grading.

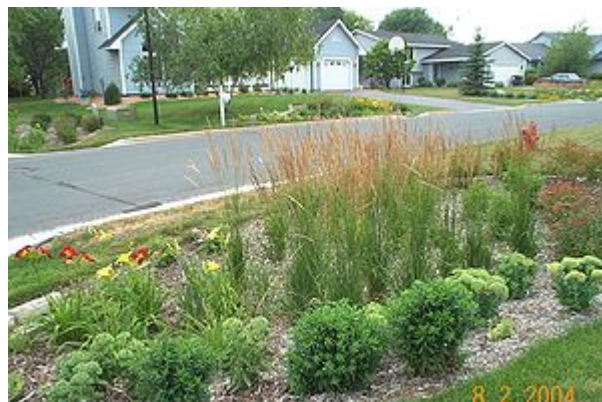
Photo illustrating a completed rain garden.
