City of Wykoff - stormwater remediation in a karst area

Project summary

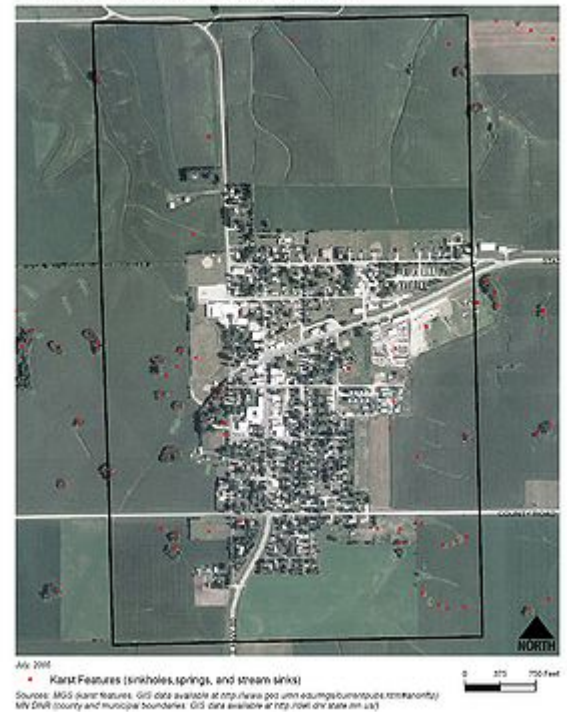
Figure X. Karst Features in Wykoff, Minnesota

Aerial photo showing the location of inventoried sinkholes in the Wykoff area

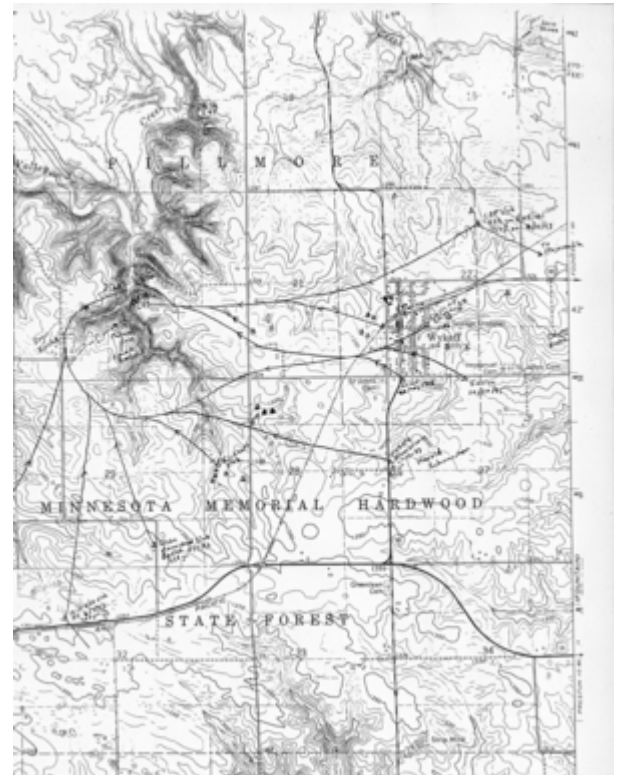
Map showing groundwater flow patterns in Wykoff area as determined by dye tracer studies

The City of Wykoff is located in western Fillmore County. From 1992-1994, the County Geologic Atlas (http://www.dnr.state.mn.us/waters/groundwater_section/mapping/index.html) was created by the Minnesota Department of Natural Resources (DNR) and the Minnesota Geological Survey (MGS) (<http://www.mngeo.state.mn.us/>). This project included several dye tracing studies in the Wykoff area. Studies indicated that dye traveled rapidly through the karst features and emerged through springs which fed the nearby trout streams of Mahoods Creek, Watson Creek and Spring Valley Creek. DNR Waters and University of Minnesota Geology Department (<http://www.geo.umn.edu/>) staff did two additional dye traces from stormwater receptor sinkholes to demonstrate the connection between them and the springs on Mahood's Creek and allow for future monitoring.
