Lake Phalen shoreland restoration - shore restoration of a high-use urban lake

Project summary

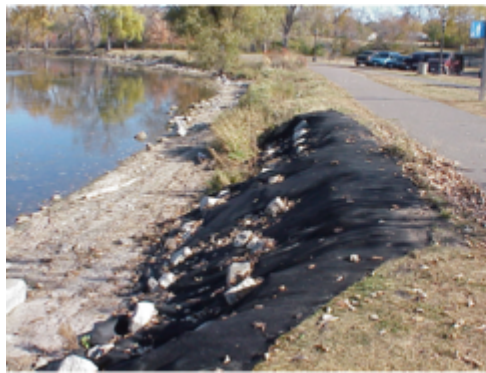
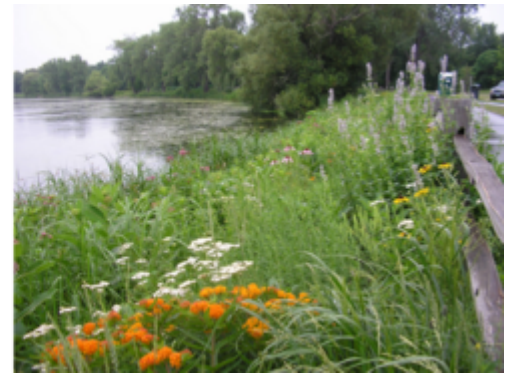
Photos illustrating the south shore of Lake Phalen before and after restoration

Immediately after park acquisition in 1899, wetlands along the shore were filled to create open turf spaces to the water's edge, and a base for roads and pathways. Historical city documents report that “dredge material is used for filling low, marshy land adjacent to the lakeshore, and these now unsightly places are being converted to lawn spaces.” These disturbances spurred shore erosion and beginning in 1910, rock rip rap was used as a fix.

Site factors (e.g., hydrology, wave action, sediment type, slope, human disturbance) influenced the restoration approach and the target plant community types. Also, aesthetics, lake views and access shaped the plant lists. Heavy machinery was used to remove old rip-rap and to recontour the shore slopes in preparation of the plantings.

A variety of re-vegetation approaches were tried in the transitional and emergent zones. Along the shore, rock berms and coconut rolls (i.e., biologs) were installed to protect young plantings from wave action. Synthetic and biodegradable erosion control blankets were used along the toe of the slope. A variety of custom grown plant material was used, including pre-vegetated erosion control blankets (2 meters x 3.5 meters), smaller pre-vegetated blanket mats -- 0.3 meters x 0.5 meters (pv-mats), 1-gallon containers, and 4 inch pots. Time of planting was varied and survival rates monitored. Of the three main community types included in the natural buffers, the emergent zone has presented the most challenge in Lake Phalen. This is due to water level fluctuation from stormwater inputs, wave action, human disturbance, and muskrat. In the transitional and emergent zones, 1-gallon containers and pv-mats had the highest rates of survival. Bulrush (*Scirpus* sp.) had good establishment and expansion via rhizomes when pv-mats were used. In some areas supplemental planting was necessary when a particular planting method showed marginal results. Lake access points – limestone steps down to the water - were incorporated into most restoration segments. This increased safety and also reduced the amount of foot traffic in the natural buffer areas.

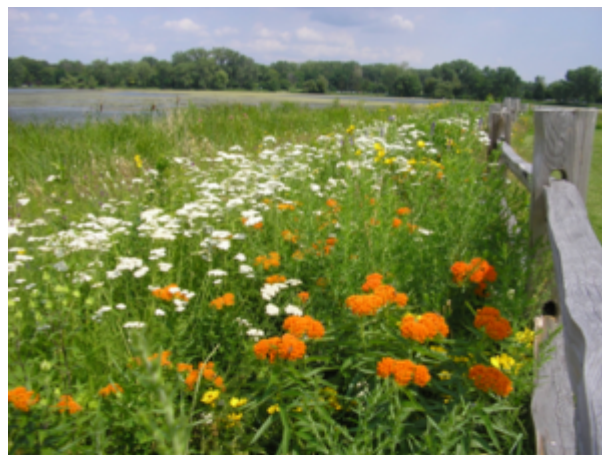
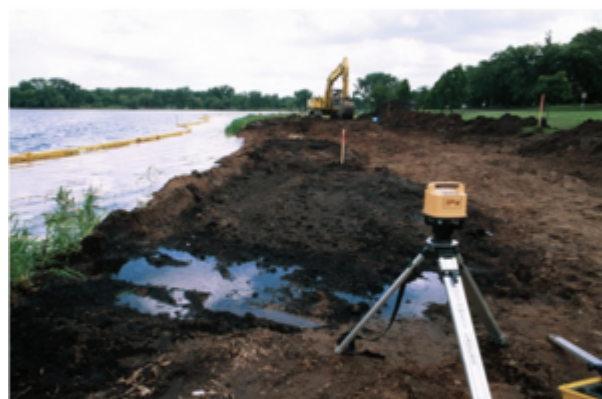
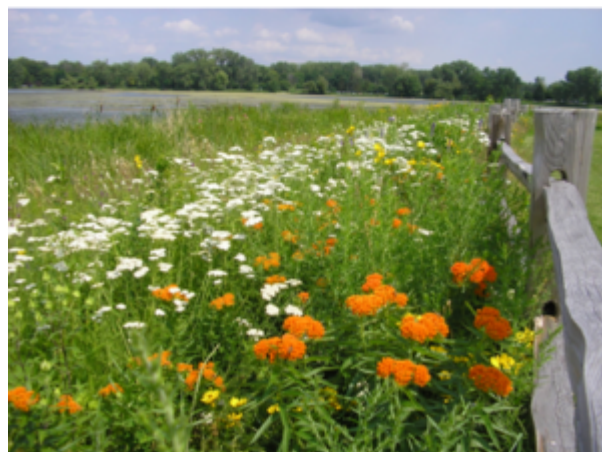
Photos illustrating the west shore of Lake Phalen before, during and after restoration
