Arlington-Pascal Project

Prior to the implementation of the Arlington-Pascal Project, an area west of Como Lake known as the Como 7 subwatershed (see right photo), experienced frequent flooding and contributed to the pollution of Como Lake. Como Lake was listed as an **impaired water** (https://stormwater.pca.state.mn.us/index.php?title=Special_Waters_and_Impaired_Waters) by the Minnesota Pollution Control Agency (MPCA) in the 2002 303(d) list. The impaired use is aquatic recreation, with the stressor identified as “nutrient/eutrophication biological indicators.”

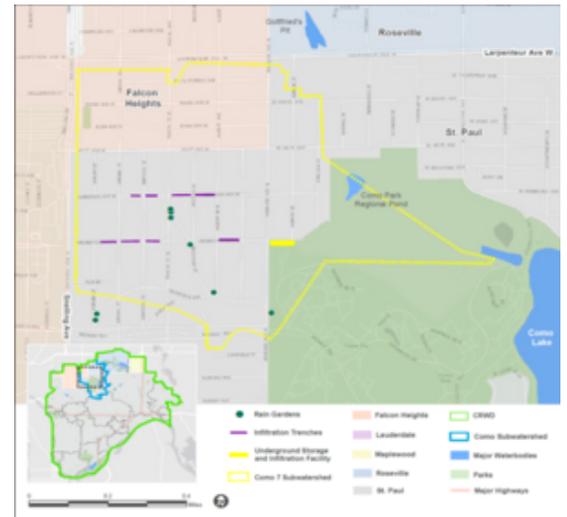
Location of the Arlington-Pascal project, Capitol Region Watershed District (<https://www.capitolregionwd.org/>).
