# Silver Creek Cliff Trail - meeting stormwater discharge requirements using compost

### **Project summary**

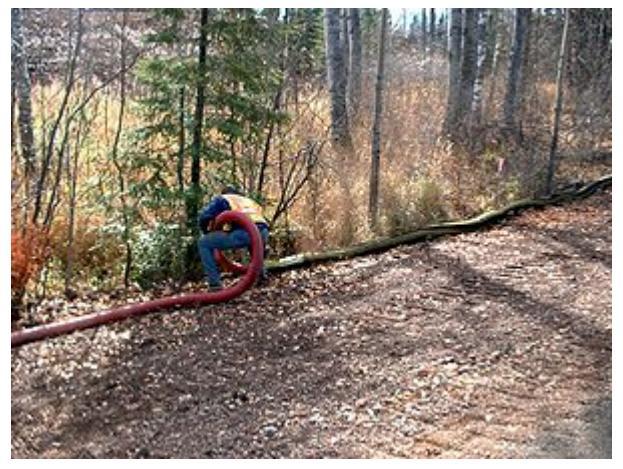
Photo illustrating perimter control using compost filter logs.

Stabilization was required within 3 days in areas with 1:3 or steeper slopes and within 7 days in areas flatter than this. The rapid stabilization plan utilized compost filter logs for perimeter control, ditch checks, and field inlet protection, and bioretention swales designed to meet the requirements. Temporary erosion control practices included in the hybrid SWPPP described rapid stabilization procedures for ditches, inlets, outlets, and ditch checks within 1 day and plans included detailed descriptions of where each stabilization standard applied on the site. Since a typical living swale could not be designed to meet stormwater treatment requirements with the soil features at the site, a compost bioswale system was designed for water retention, filtration and nutrient capture. This bioswale was developed for water quality treatment using known parameters of leaf and grass clipping feedstock compost.

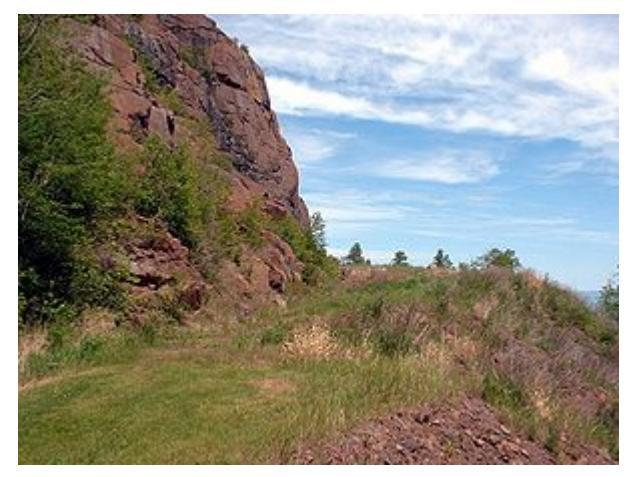
Photo showing constraints at the Silver Creek Cliff site.

Site constraints in the project area made implementation of traditional stormwater management techniques impractical and unfeasible for the site. All stormwater from the project drains through multiple exit points to Lake Superior, which has prohibited and restricted discharge areas and a special water of the state. Peregrine falcons have established nesting areas in the rock face above the trail site, so the project had to avoid disturbing the birds during their critical nesting season. Rare plant species were identified at the toe of the slope requiring a design configuration of the project to avoid impacting them. The design also had to complement the historic nature of the site itself and not obstruct or adversely alter the historic viewshed of the lake. Stormwater management was further complicated by underlying soil materials, since this area is dominated by exposed rock and thin soils.

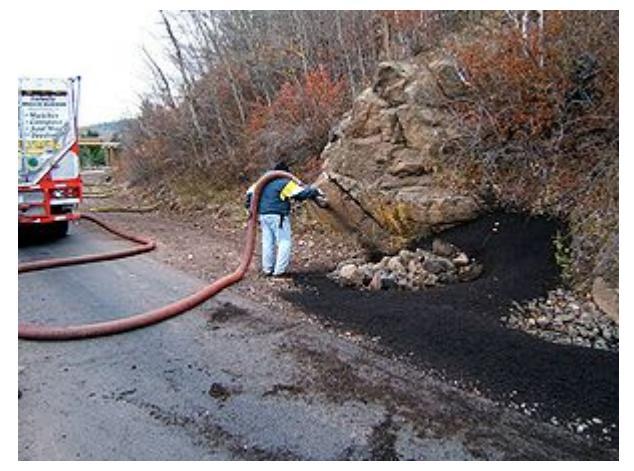
Photo showing addition of a soil amendment for rapid vegetation and stabilization.

Permanent erosion control practices included a 2 inch thick

compost blanket, slow release fertilizer and a system of vegetated swales and drainage filters for the parking lot inlet. Compost filter logs were also used as post-construction stormwater controls as the filter logs vegetated over time, and a special seed mix was developed for the project.

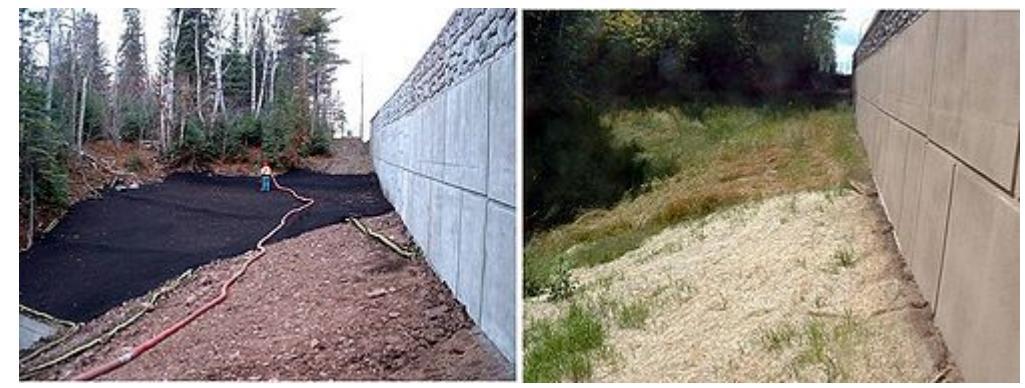
Photo showing stabilization and revegetation using compost vegetated mat (a) installation and after stabilization (b). Note that areas utilizing compost vegetated more quickly and completely than areas using the vegetative mat.

The techniques used for this project were very successful at addressing both temporary and permanent stormwater management and erosion and sediment control in shallow soils and bedrock areas with unique constraints. This project will be used as a model for future projects in areas with similar conditions.
